# PROOF THROUGH PILOT TESTING

A side-by-side comparison of leak detection technologies

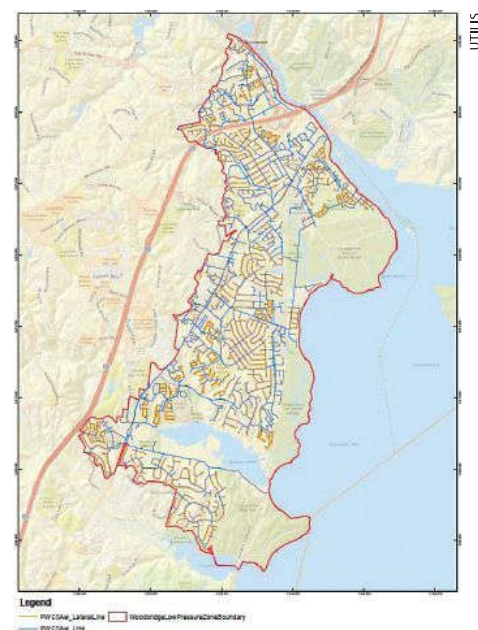
Figure 1. The area of interest evaluated in the pilot test is approximately 200 miles of water main and service pipe.

The PWCSA focused the pilot study, technology validation program, and AOI on the Woodbridge low pressure zone. This area includes approximately 200 miles of water main and service pipe as shown in Figure 1. This location was chosen due to its elevated age of pipe and because it has an estimated real water loss of 15%, which is above other sections of the PWCSA system.
